NATIONAL PROGRAM FOR INSPECTION OF NON-FEDERAL DAMS
SMITH POND DAM (NH 00..(U) CORPS OF ENGINEERS WALTHAM
MA NEW ENGLAND DIV JUL 79

SMITH POND DAM
NH 00073

PHASE I INSPECTION REPORT
NATIONAL DAM INSPECTION PROGRAM

DATE OF INSPECTION: DEC 1977
INSPECTOR: [illegible]

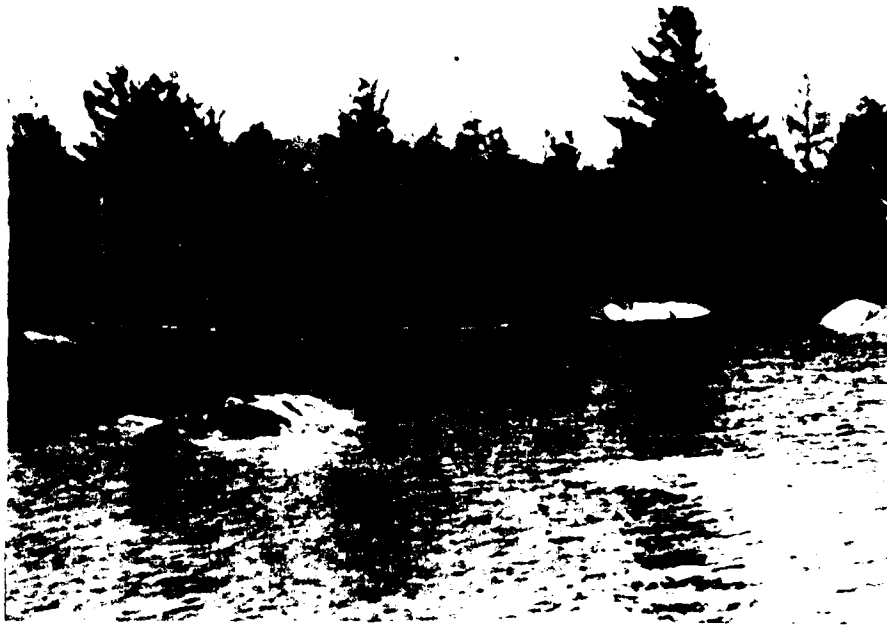
Figure 2 - Looking at upstream face of the dam from the west bank of the pond.

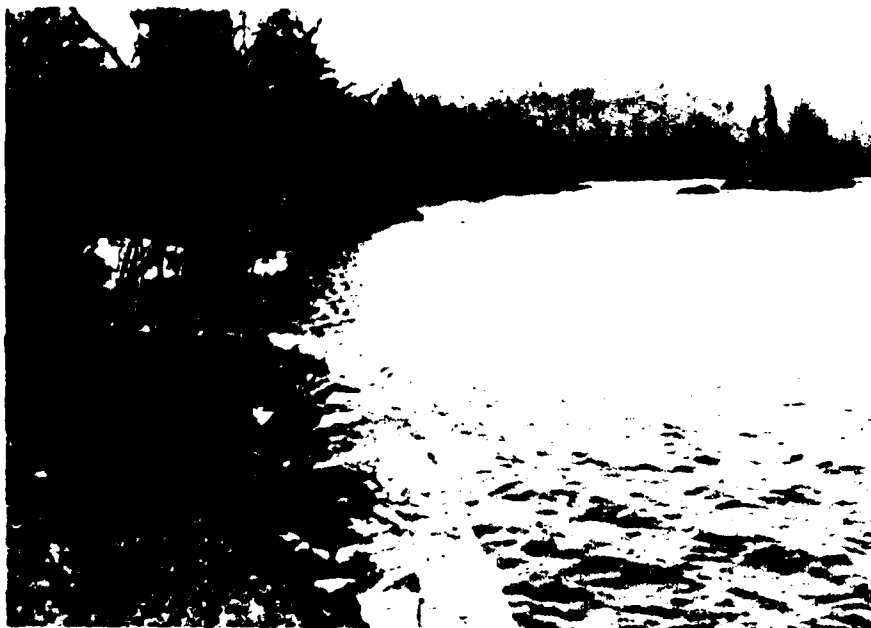
The one-foot-deep depression on the crest of the dam above the low-level outlet pipe is evidence of some past problem, which may have been overtopping, piping, or collapse of or leakage and piping into the low-level outlet pipe. The same problem may develop again and could lead to failure of the dam if remedial action is not taken. The concrete facing on the upstream face is in poor condition (poorly constructed).

Figure 3 - Looking eastward along crest of main dam from the west abutment. Note irregularity of concrete facing.

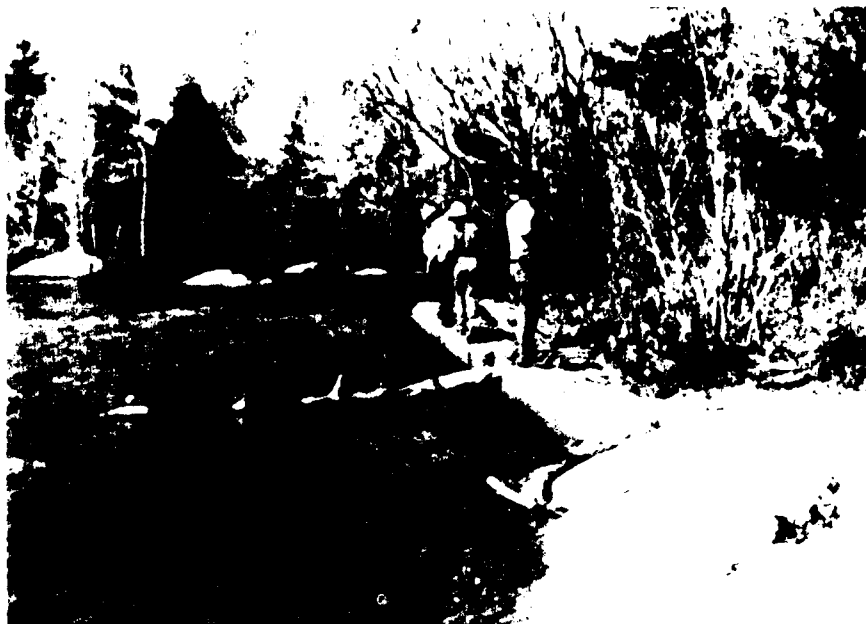
Based on the visual inspection, Smith Pond Dam is in poor condition. Brush is growing on the crest of the dam. If it is allowed to continue growing, the crest will become covered with trees. If a tree then blows over and its roots are pulled out, or if a tree dies or is cut and its roots rot, serious seepage and erosion problems may result.

May 9, 1979
Figure 6 - Looking west along crest of main dam.
Note the brush and saplings growing on
the crest of the dam.
